NIST GCR 98-757

Guide to Improved Earthquake Performance of Electric Power Systems

Anshel Schiff
Stanford University

September 1998

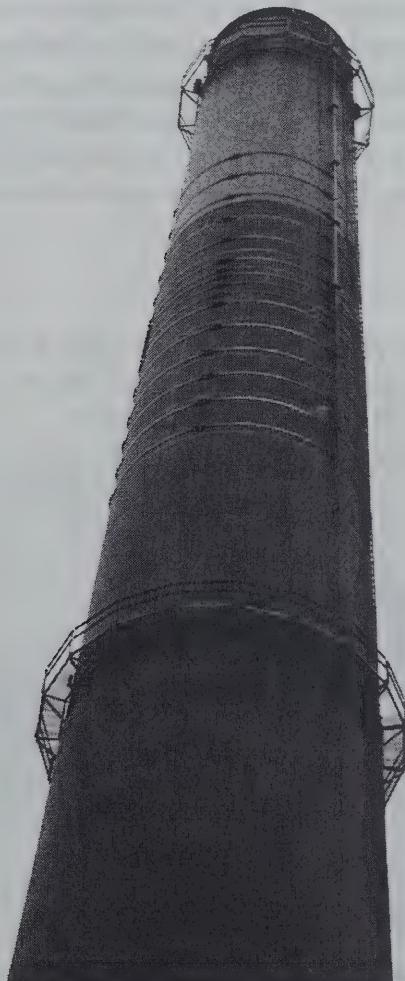
There are records of damage to stacks (chimneys) dating back to the 1886 Charleston earthquake. Most damage has been to brick stacks and appears to occur between two-thirds and three-quarters of the height. Power plant stacks are constructed with an outer reinforced concrete shell and an internal liner which may be free standing or supported by the shell. In the Loma Prieta earthquake the stack liner at a generating station broke away from the outer shell from which it was supported. Repairs included adding straps to the outer shell, Figure 7.6.

Figure 7.6 Straps were added to the stack after the Loma Prieta earthquake in which the connections between the liner and the shell were damaged.

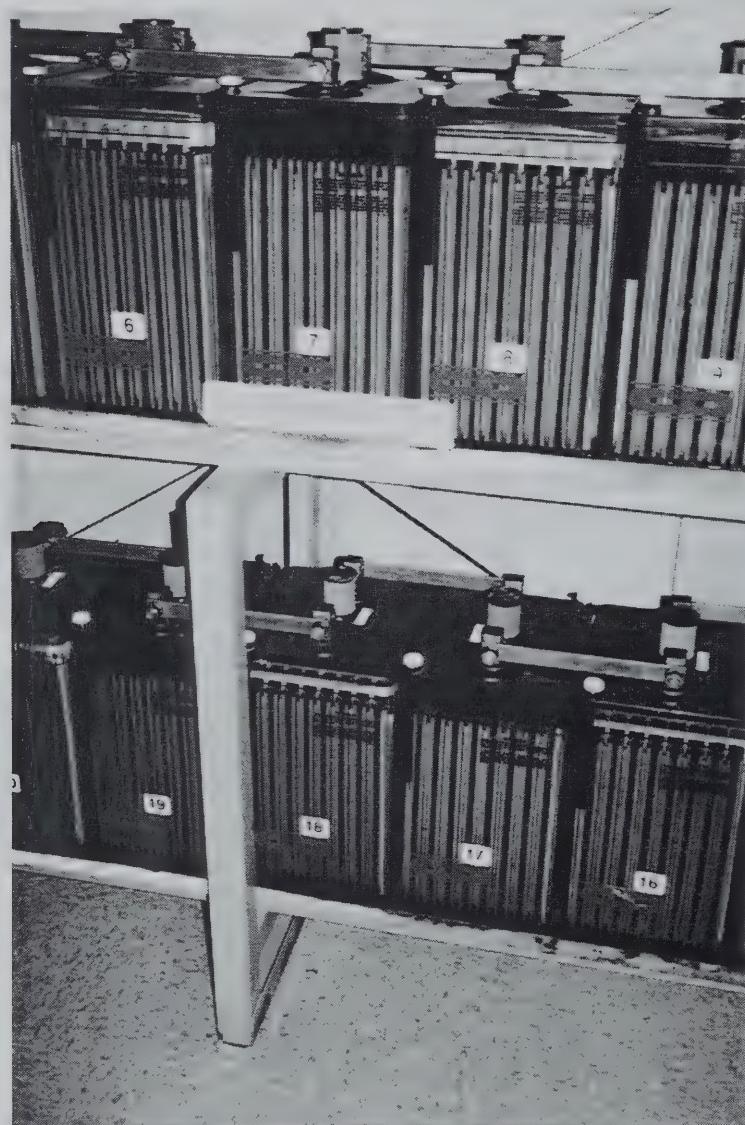
cells that have fallen from their rack or have been damaged due to impacts while on the rack. Figure 8.6 shows a battery rack used in some parts of the country in which the cells are not restrained by the rack. Moderate ground motions can cause the cells to fall from their rack resulting in cracked cases and acid spills.

Figure 8.6 Battery rack with no restraints to keep the cells on the rack.

Batteries should be restrained by their racks and should have spacers between cells, and between cells and restraints. There is evidence that impacts between adjacent cells and between cells and their restraints can crack cell cases. Heavy cables should be restrained so that cable dynamics do not add loads to connection hardware or binding posts. There should be adequate slack to accommodate rack movement.

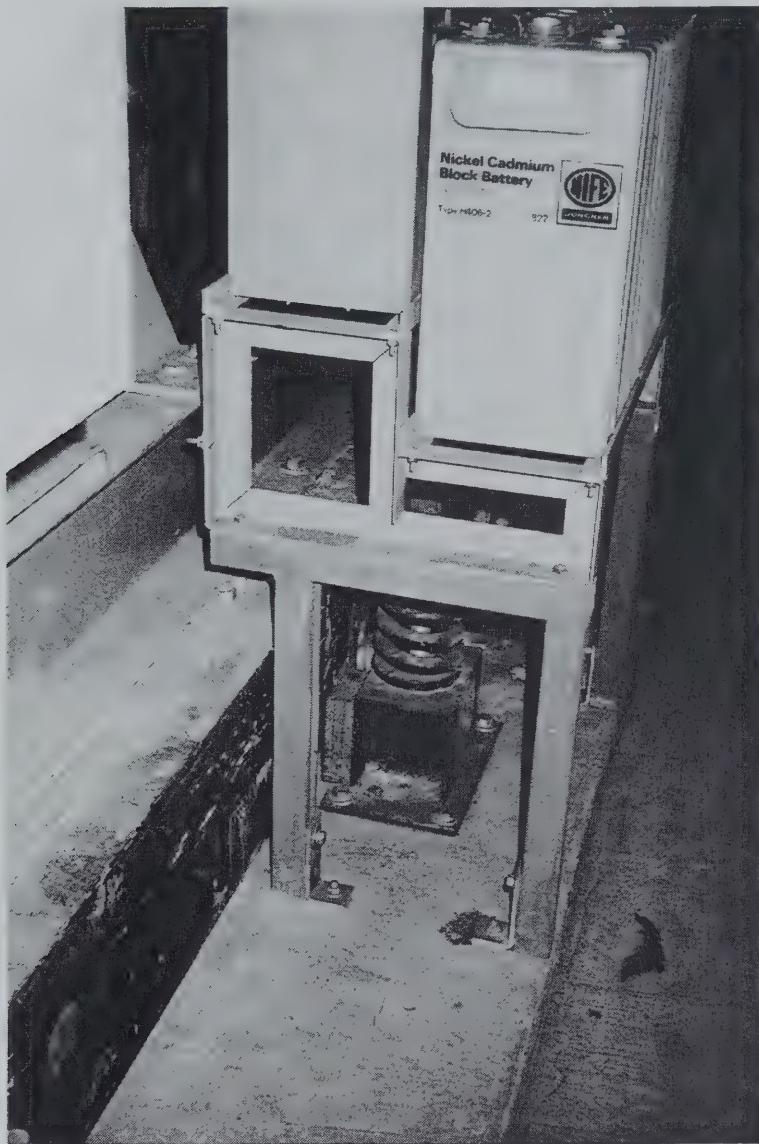
Figure 8.10 A large battery used to start an engine-generator was poorly anchored. Vibration isolators and snubbers can be seen below the battery.

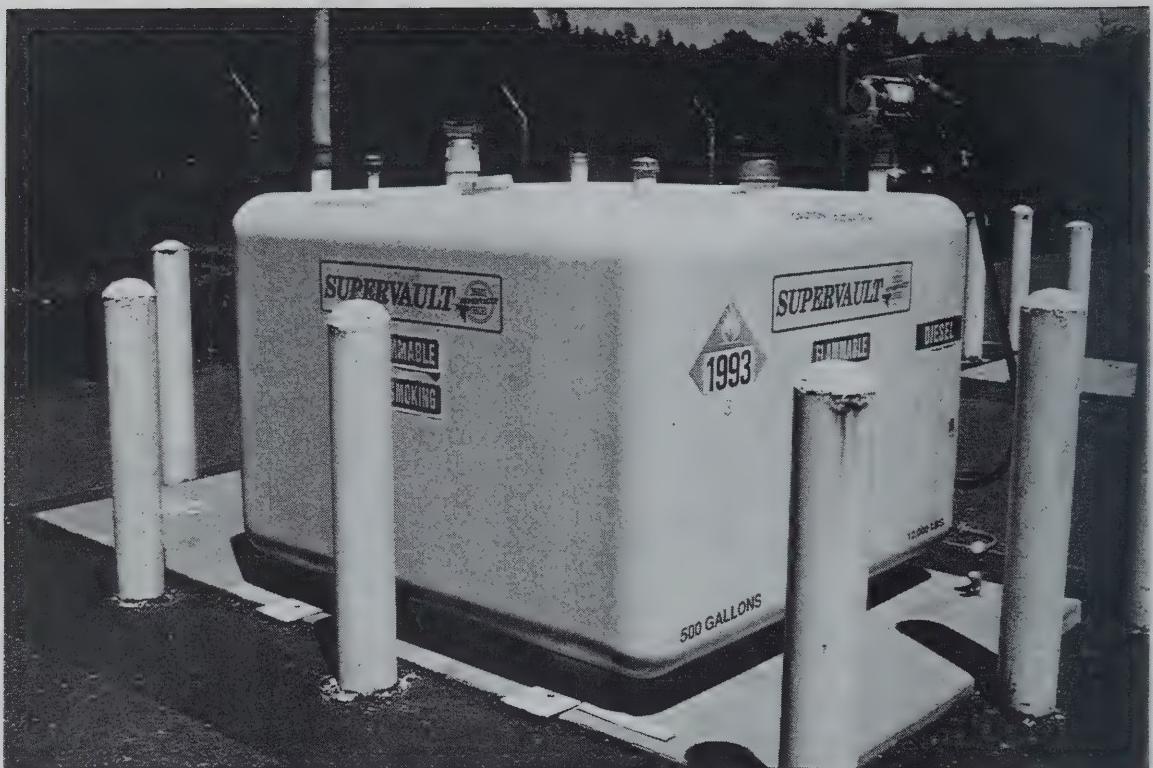
Most engine-generators have a main fuel tank of 500 to 2000 gallons. Older tanks were typically buried, but EPA regulations now require that old tanks be replaced with double-walled tanks, and other requirements favor the use of above grade tanks, as shown in Figure 8.13. Above ground tanks are frequently unanchored and connections can be damaged if they slide, Figure 8.14. One of the problems with large fuel tanks is that the fuel can sit in the tank for a long time before it is either consumed or replenished during

Figure 8.13 Typical fuel tank that replaces older buried tank.

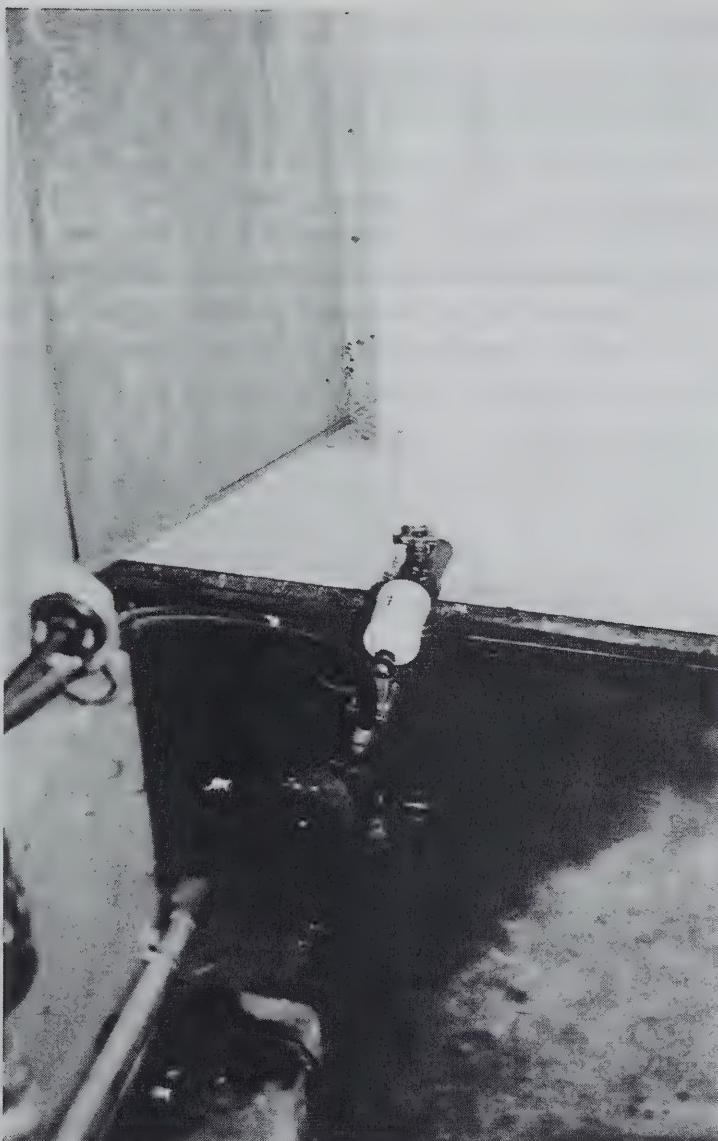
Small engine-generators often use bottled-gas as a fuel source. This has the advantage that the fuel will not degrade with time and no day tank is needed. Bottled-gas tanks are frequently inadequately anchored, and units have moved in an earthquake and broken the fuel line. Gas leaks in a small enclosure housing the engine can cause an explosion if an ignition source is provided. After a utility experienced an explosion (not related to an earthquake), small ventilation fans and gas detectors were added to gas-fired units. It is important to protect piping from secondary damage. Figure 8.15 shows a gas line that supplies the engine-generator that could be damaged by an adjacent unanchored storage cabinet.

Figure 8.15 A small diameter gas line that fuels an engine-generator is vulnerable to damage from a nearby unanchored storage cabinet.

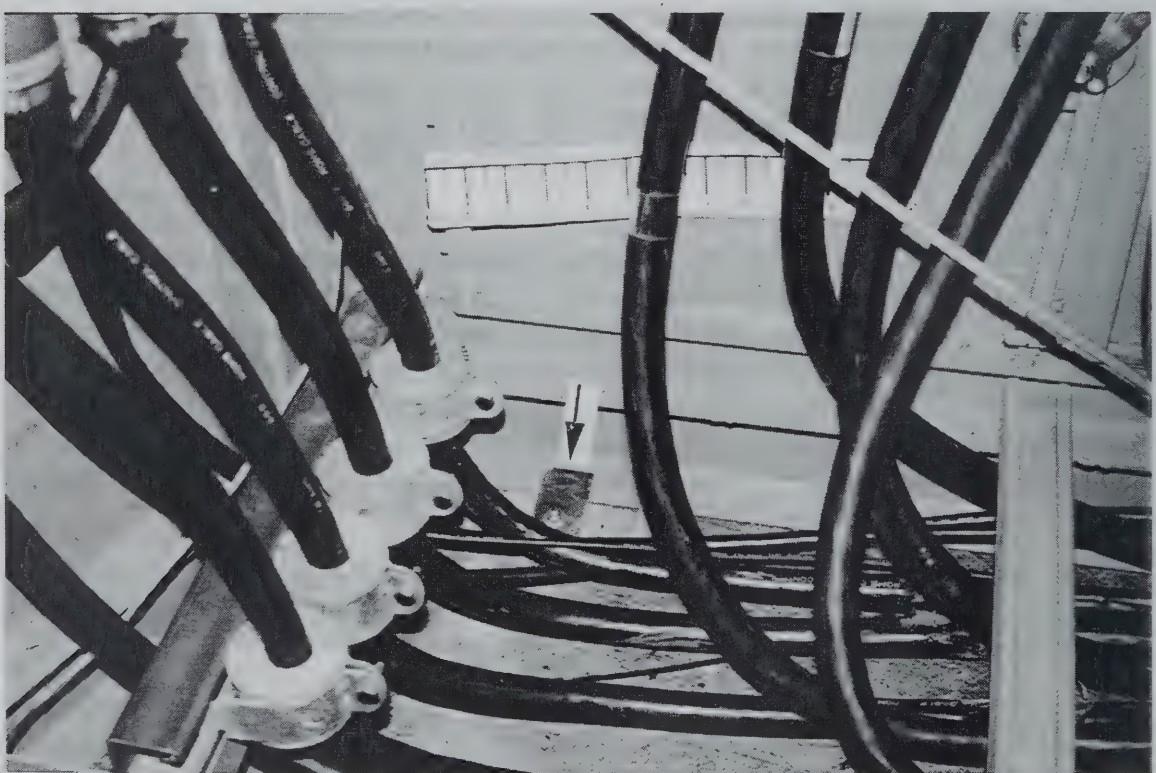
Figure 8.17 Friction clips used to anchor control consoles are unreliable. If the console moves, the cables entering through the floor may be cut.

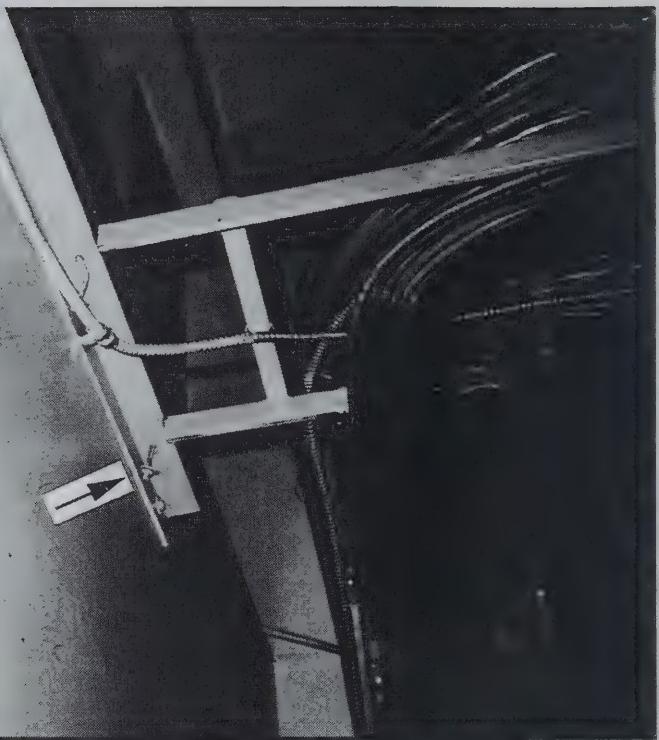
Cable trays used in the communication industry typically are ladder-type trays. Sections are joined by friction clips, Figure 9.4, that provide very little load capacity in tension when used to brace equipment racks. Cable trays are often anchored to walls with the use of J bolts, which can open in an earthquake, Figure 9.5.

Figure 9.5 J bolts are often used to secure cable trays to structural walls.

It is recommended that power-system type cable trays be used for communications equipment. These trays have bolted connections between cable tray sections. If communication-type cable trays are used, sections should be joined with bolted connections. J-bolts should not be used as structural connections. The performance of communication-type cable trays used as braces can be improved if they span from wall-to-wall. Cable drops from cable trays to equipment should be provided with ample slack to accommodate relative motion between the tray and the equipment.
